# Manhole Inspection Summary

Manhole # S06II2014MH

Insp Date: **9/21/06 11:25 AM**

**Location** Address: **3509 SHELBURNE RD**

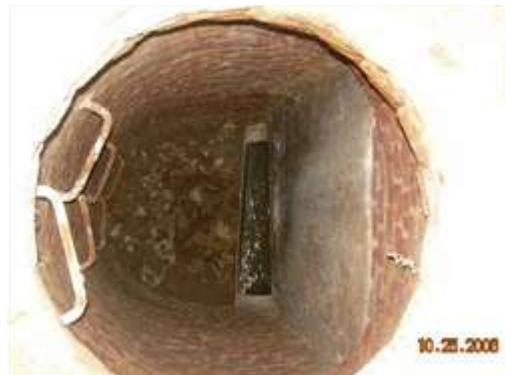
Top View

Adjustment infiltration. Evidence of surcharge - Bench debris. Corroded steps.

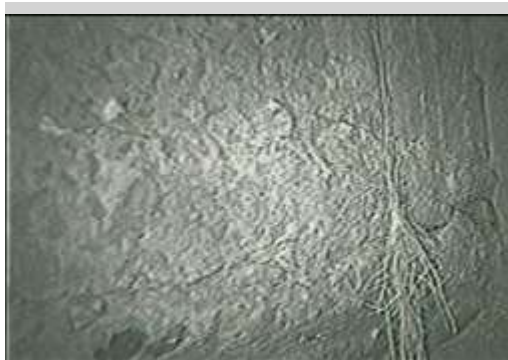
Defect

Barrel root intrusion, deterioration and infiltration.

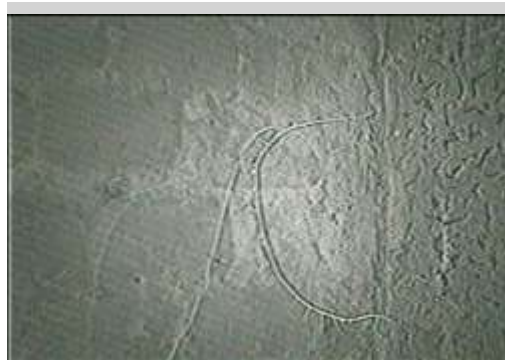
Defect

Barrel root intrusion and infiltration.

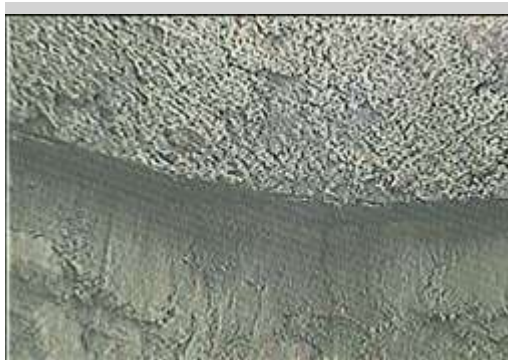
Defect

Adjustment infiltration.

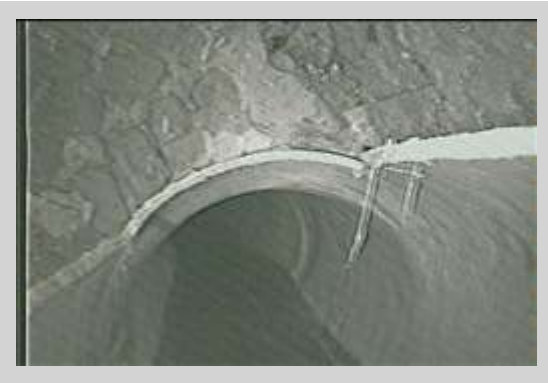
### 18 in. Circular Gravity Sewer Pipe Out @ 12 O'Clock

Barrel deterioration and infiltration.

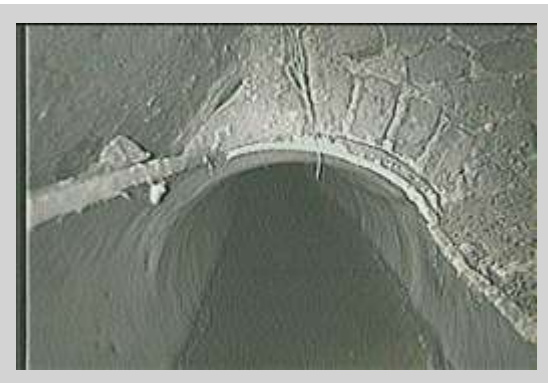
### 18 in. Circular Gravity Sewer Pipe In @ 6 O'Clock

Barrel deterioration, root intrusion and infiltration.
